County of San Mateo - Planning and Building Department

ATTACHMENT K

**ENGINEERING GEOLOGIC &
GEOTECHNICAL INVESTIGATION
4 LOT RESIDENTIAL DEVELOPMENT
ZMAY PROPERTY
1551 CRYSTAL SPRINGS ROAD
SAN MATEO COUNTY, CALIFORNIA**

RE: ENGINEERING GEOLOGIC &
GEOTECHNICAL INVESTIGATION,
4-LOT RESIDENTIAL DEVELOPMENT,
ZMAY PROPERTY,
1551 CRYSTAL SPRINGS ROAD,
SAN MATEO COUNTY, CALIFORNIA

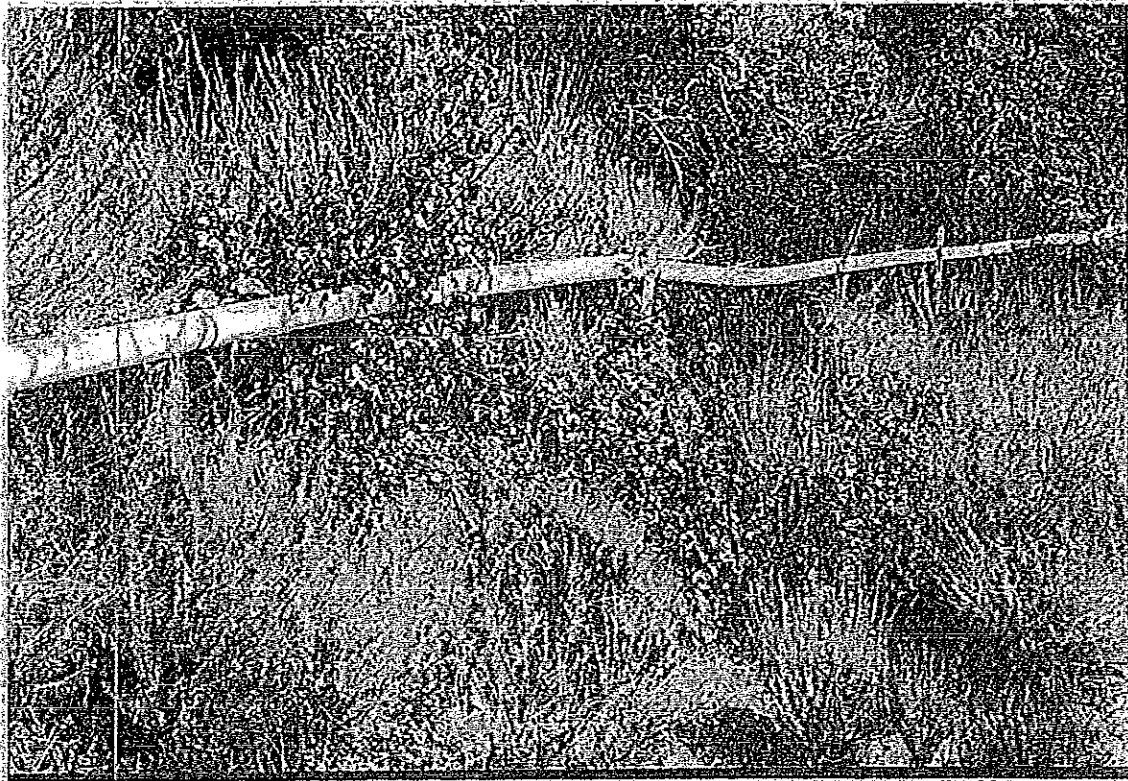
Temporary 4" PVC bypass pipe installed below Parrott Drive

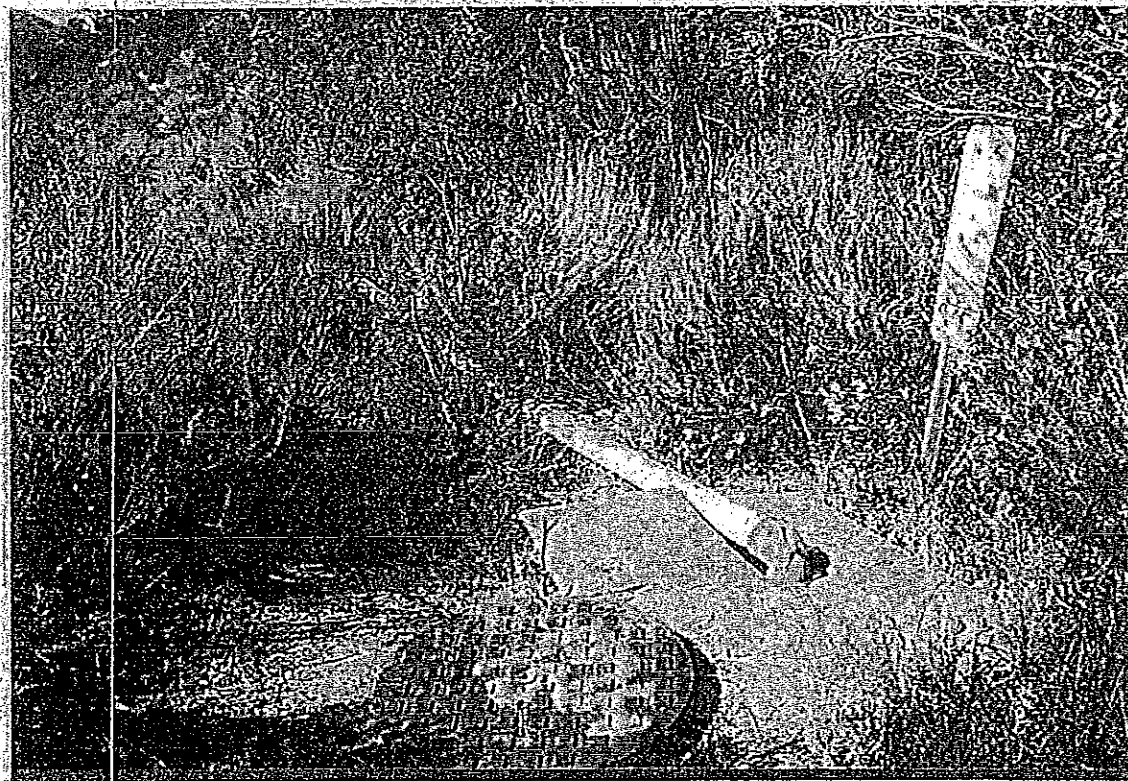
Temporary Bypass Pipe from MH 17 entering MH 15

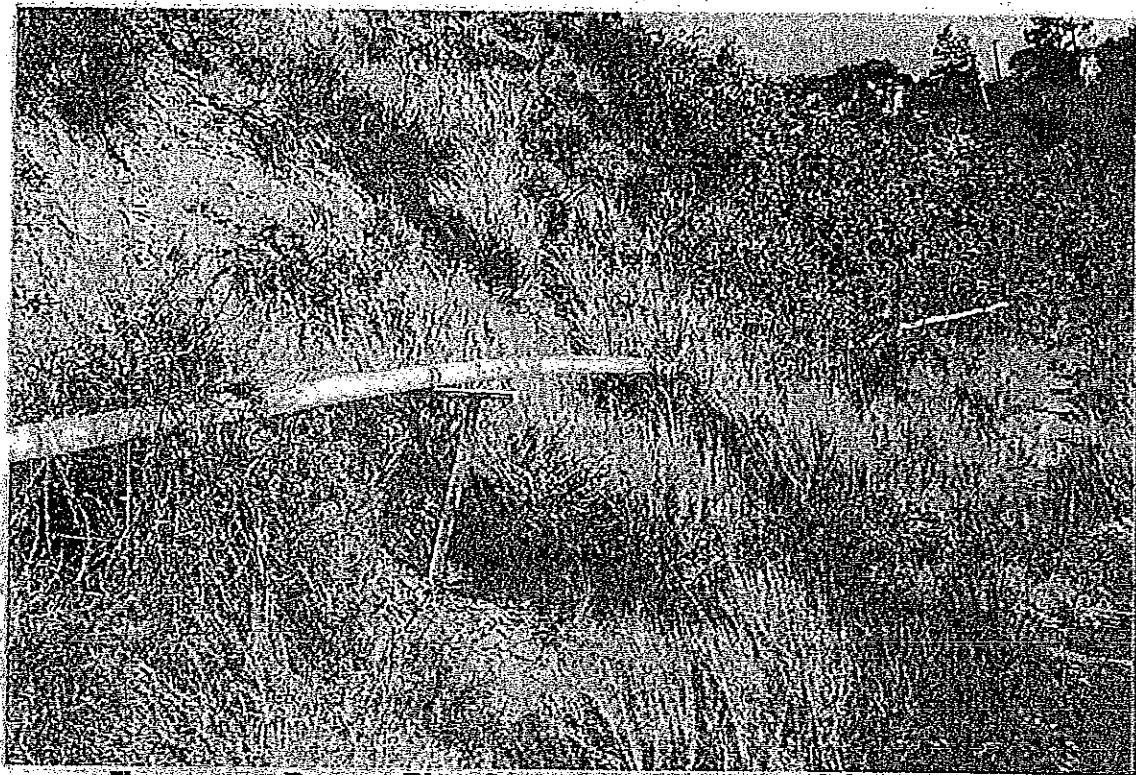
Temporary Bypass Pipe Supports between MH 15 and MH 17

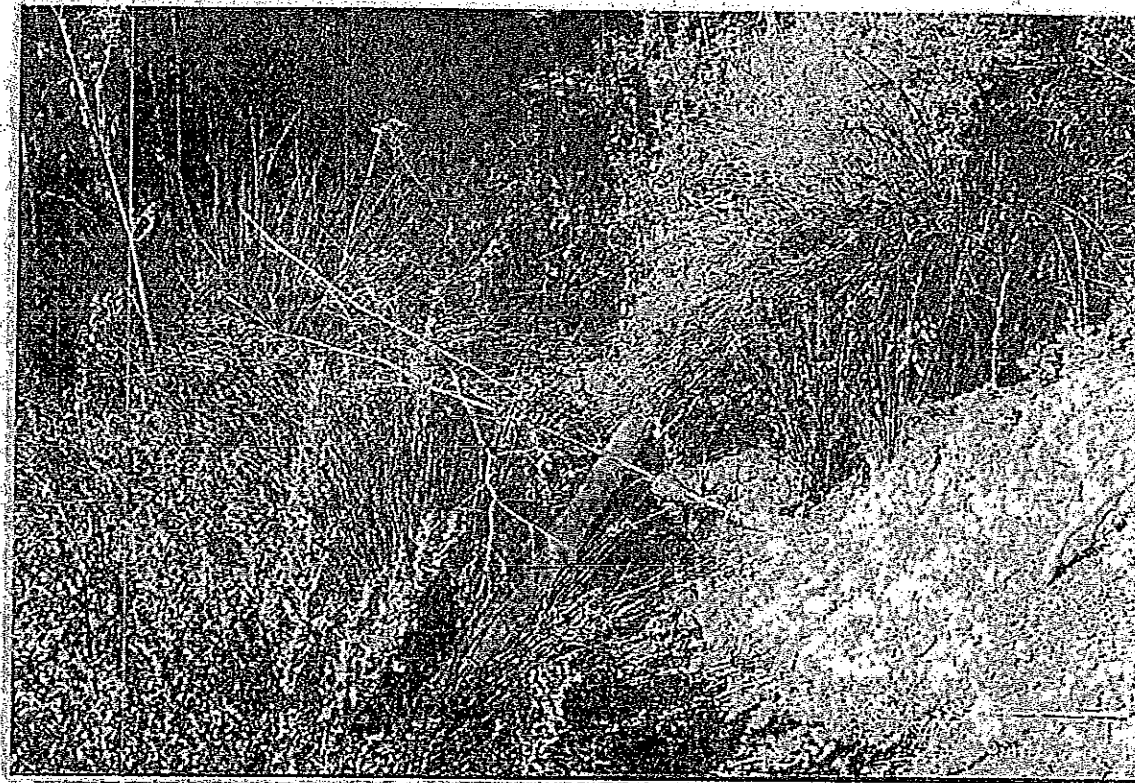
Temporary Bypass Pipe on ground between MH 11 and MH 14

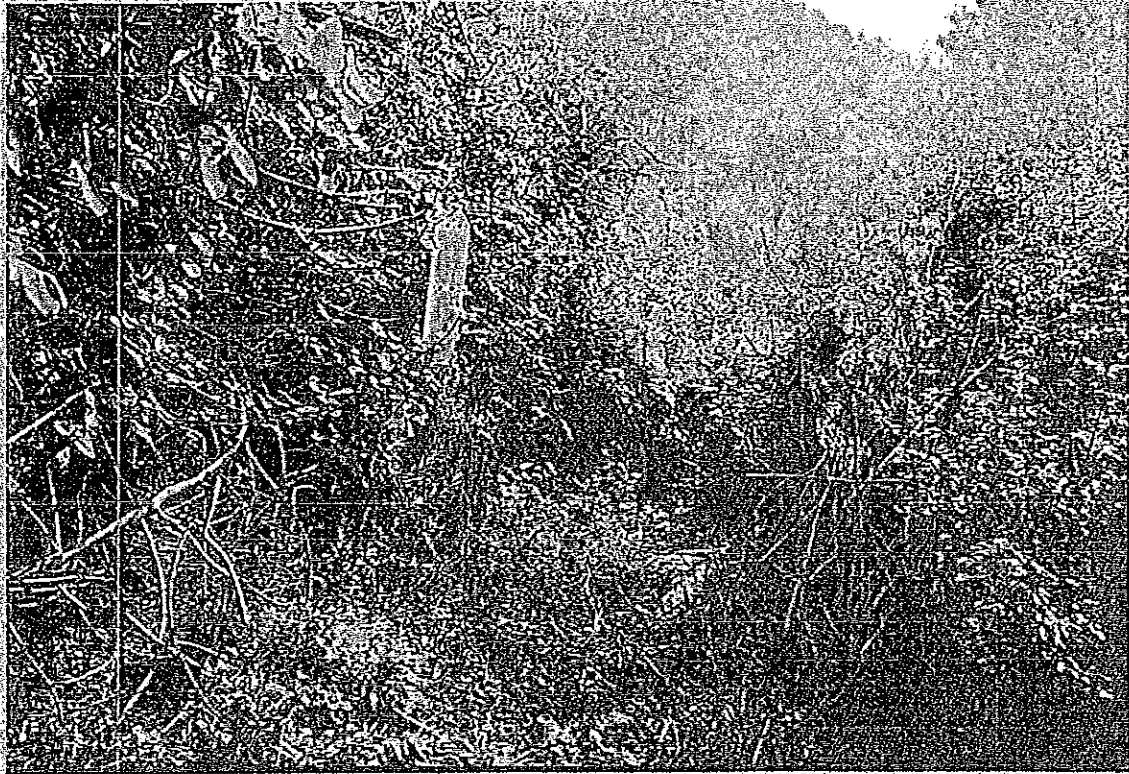
Example of difficult access – MH 13

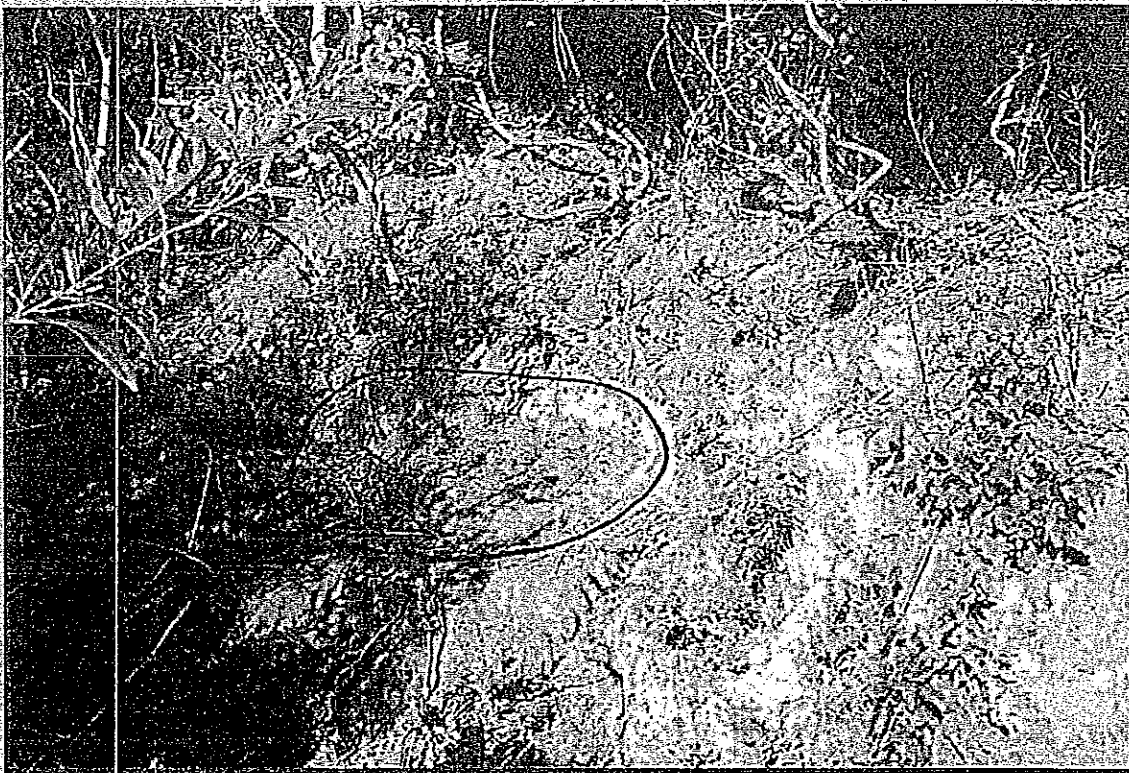
Example of MH re-exposed after being covered by sliding hillside

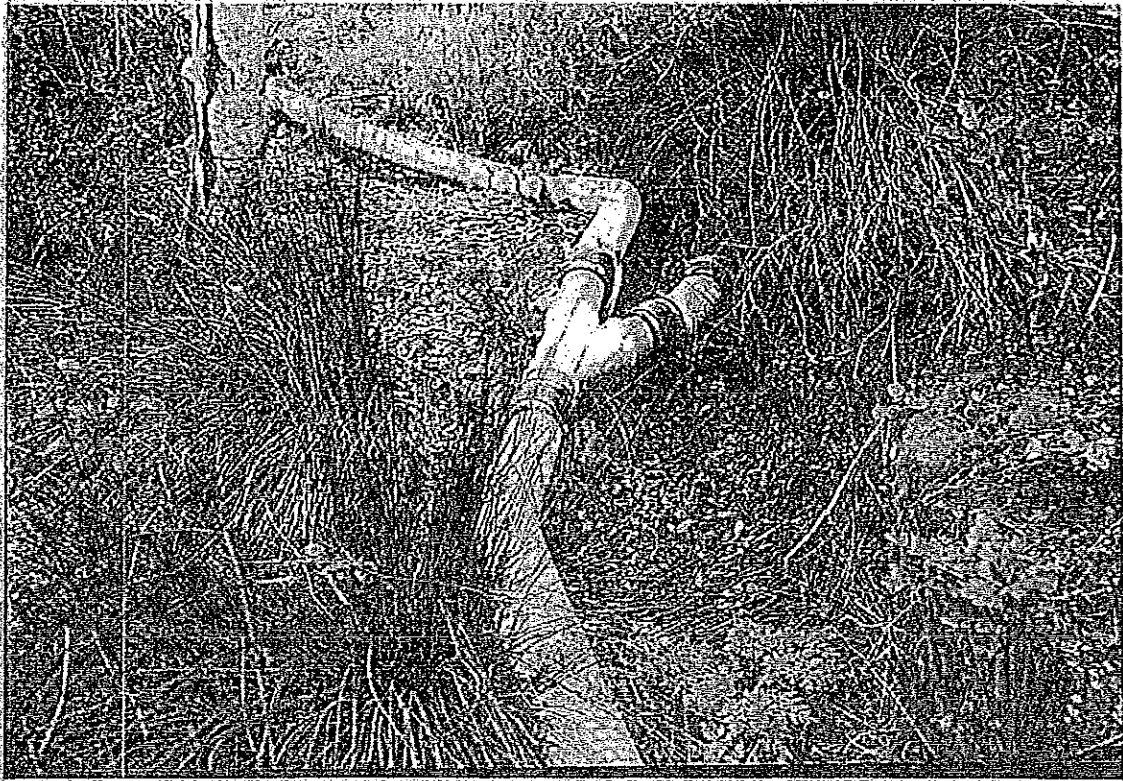
Laterals from 1306 & 1312 Bel Aire Road are connected into one 4" flex pipe

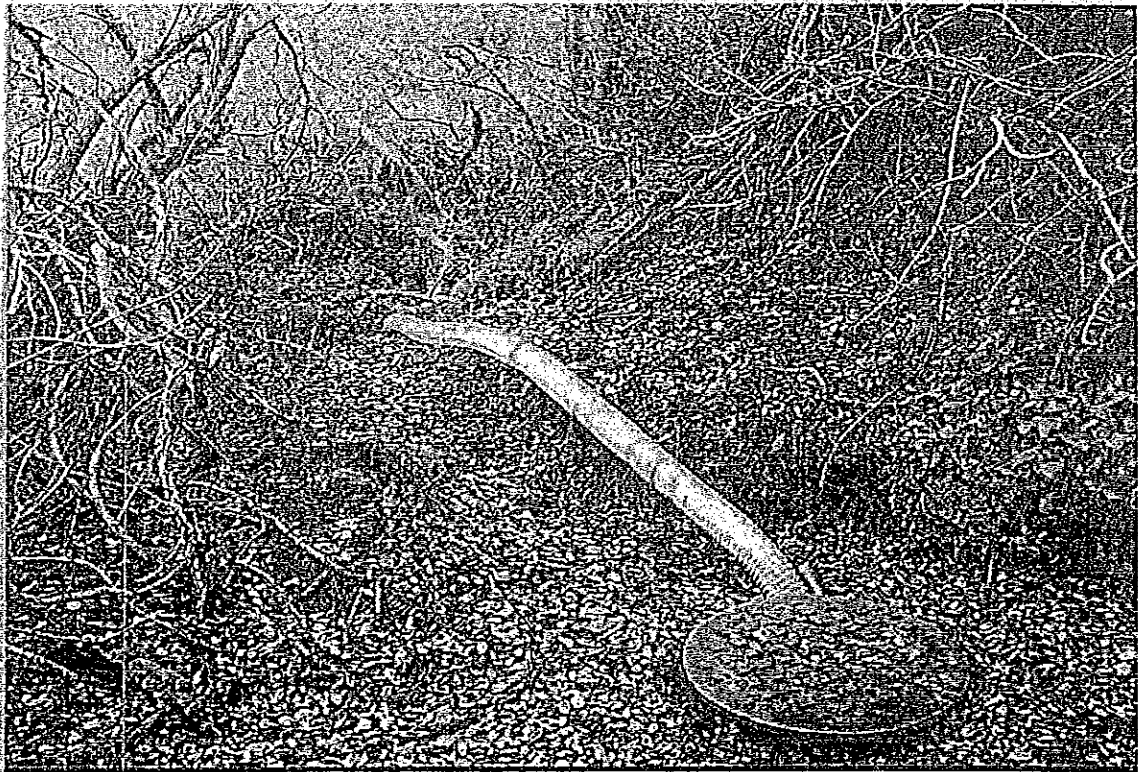
Combined laterals flowing into MH 30

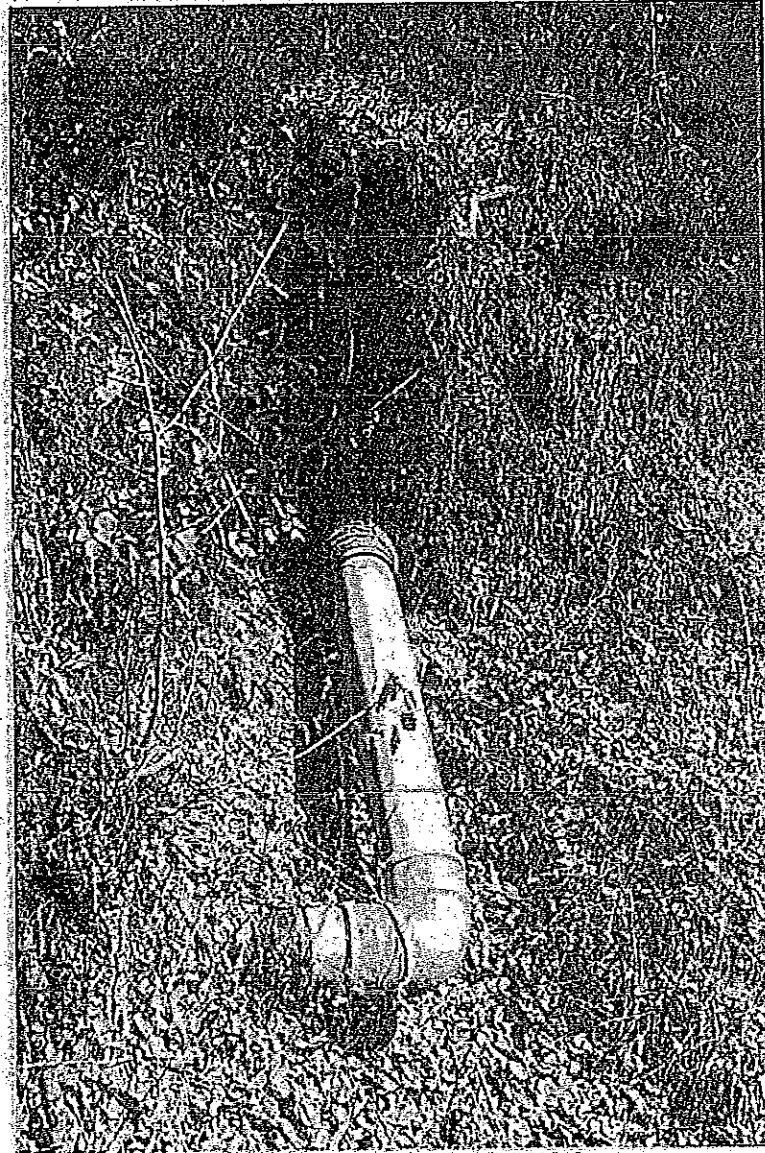
Former Location of MH 6

It is likely that, as the MH base began to move and become separated from the pipe, sewage flow from the exposed pipe caused the final erosion around the MH base. The resulting erosion left the brick MH upside down and completely in tact, approximately 30 feet down the hill near the creek. While difficult to pick out in the following photograph, it serves as a reminder of the potential that a remote pipeline on a slipping hillside has to cause damage.

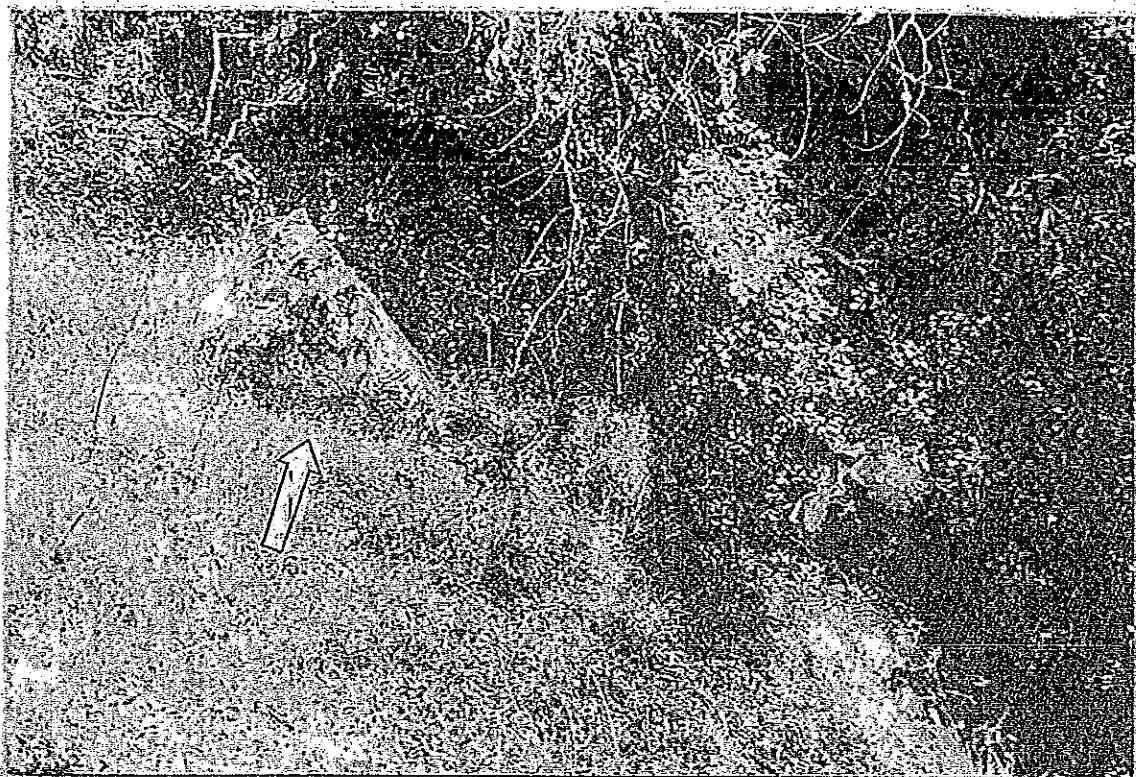
Upside down MH 6 in it's new, unused location
