## **GEOTECHNICAL STUDY**

**MUKAEDA PROPERTY  
CYPRESS AVENUE  
MOSS BEACH, CALIFORNIA**

June 24, 2020

Subject: Geotechnical Report for Proposed Construction at Cypress Avenue, Moss Beach, California. (APN's: 037-221-020,030)  
Sigma Prime Job No. 16-128; PLN2020-00070

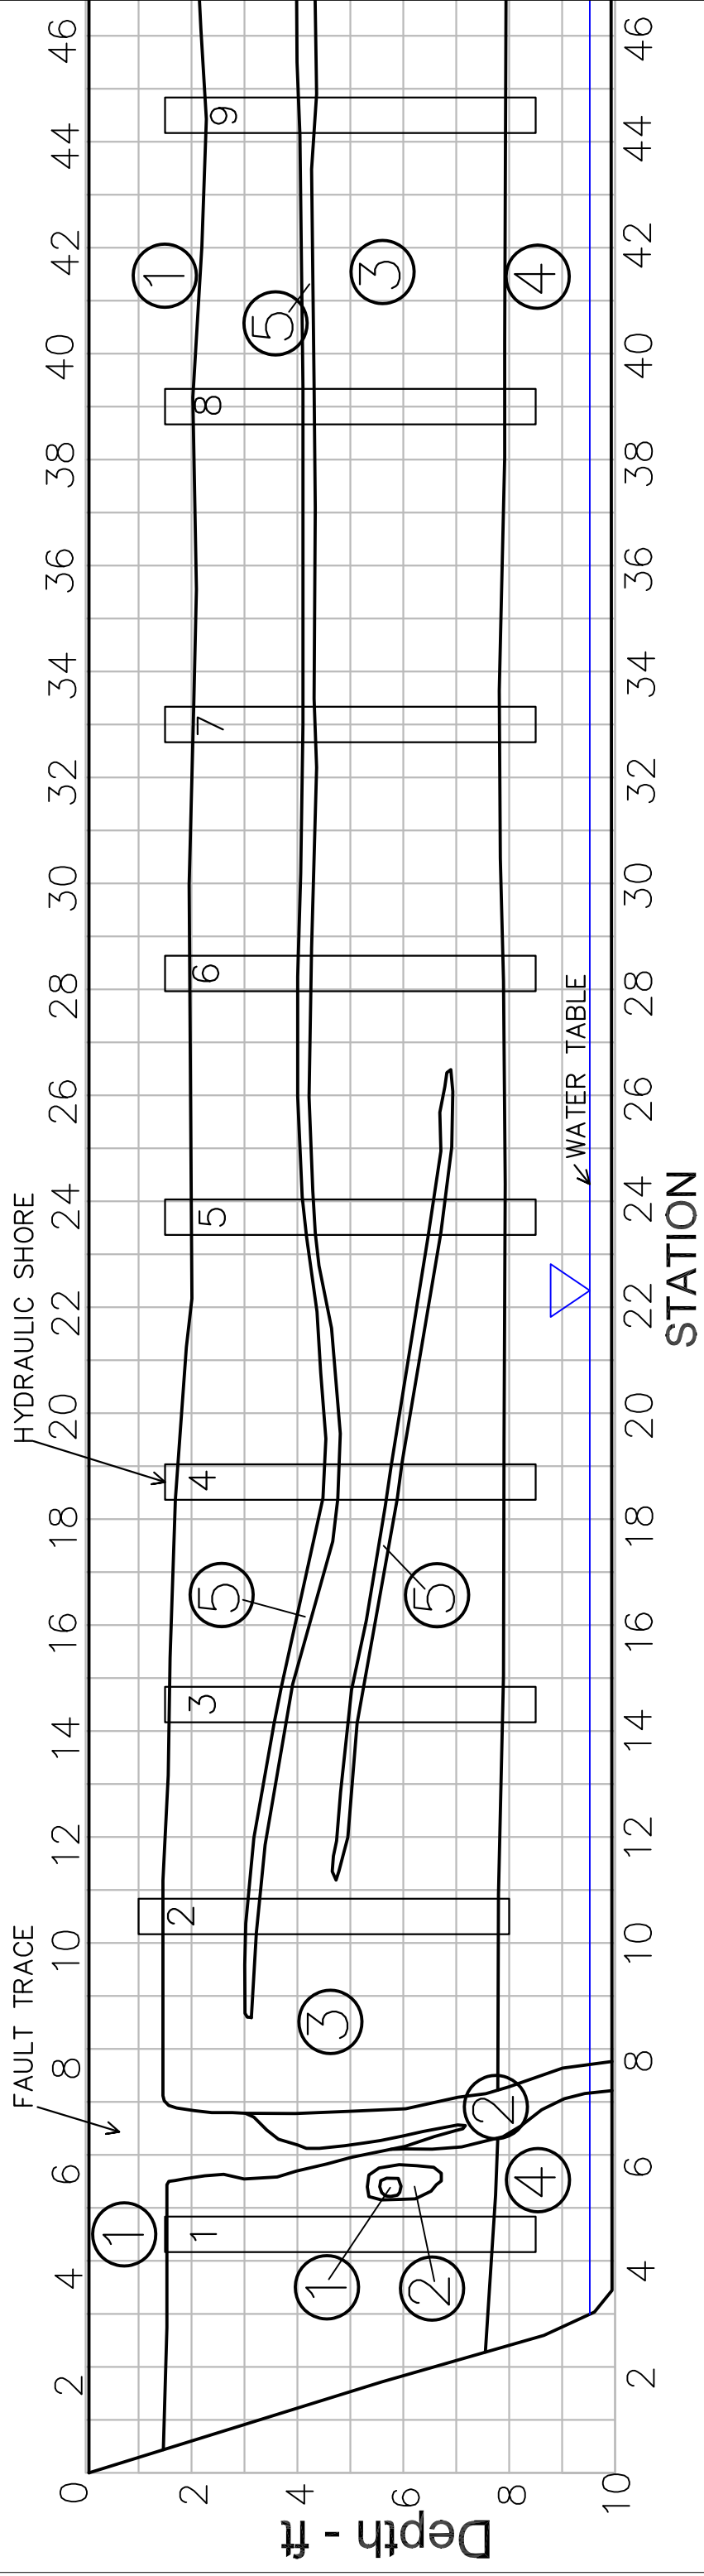
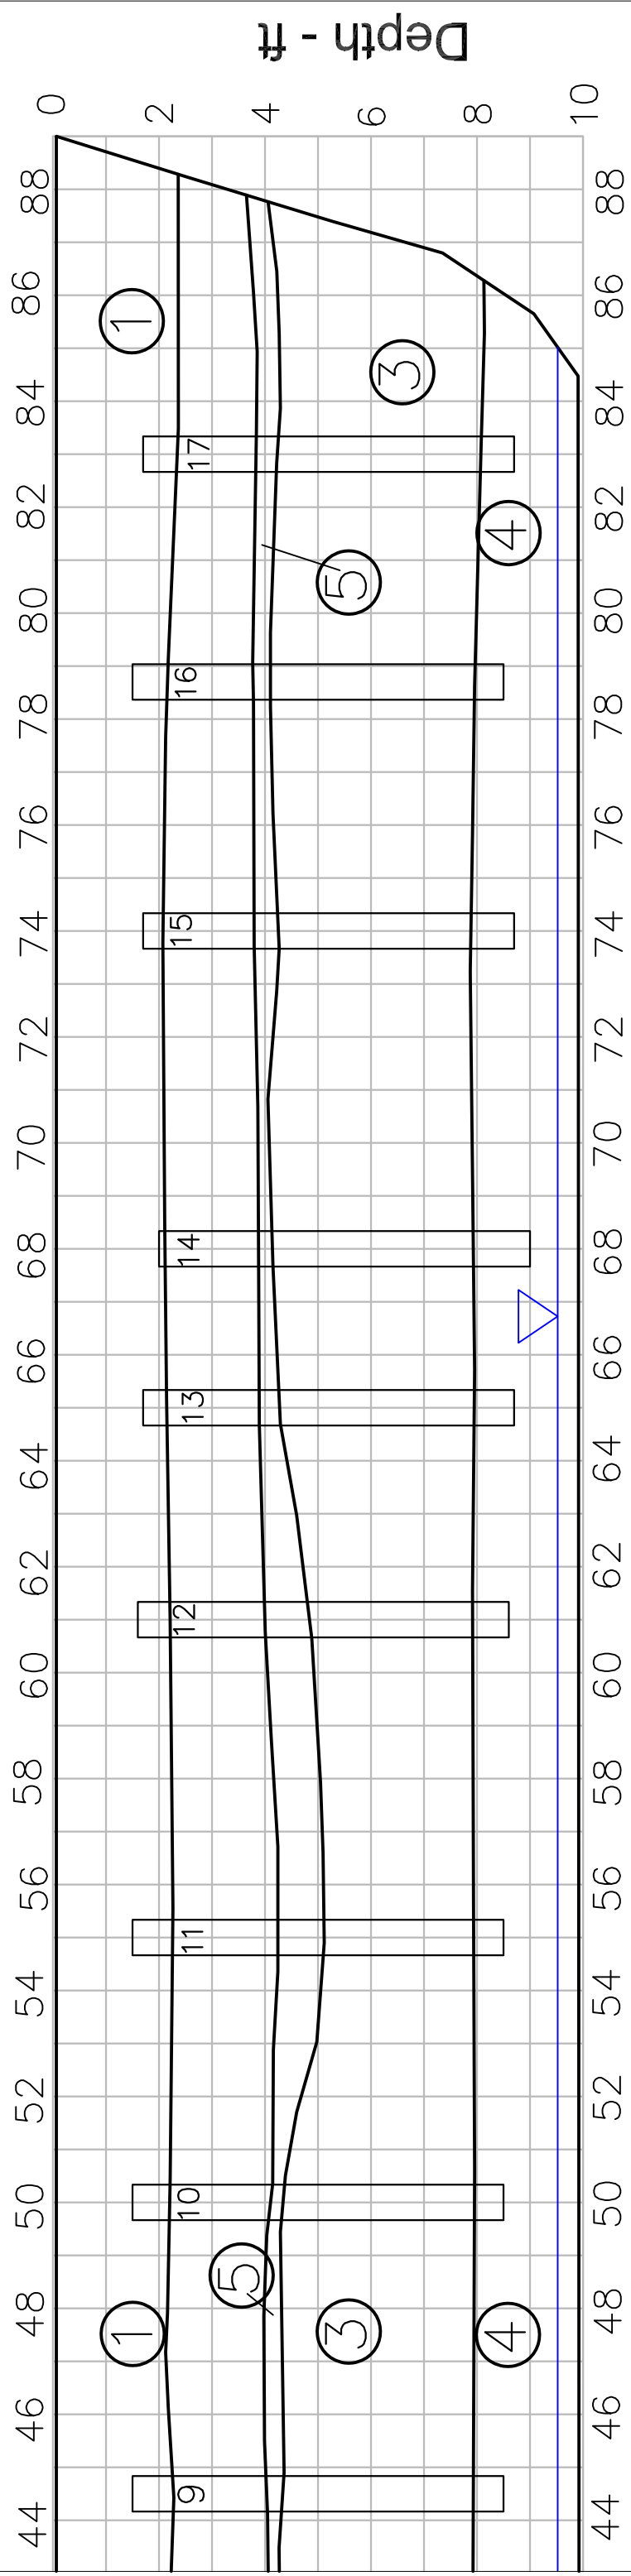
Besides the three main lithologic units, there is a thin gravelly clay marker bed that extends across most of the trench. It pinches out before it makes contact with the fault trace and is undisturbed. The fault trace feature consists of a tension crack that is in-filled with topsoil from above and an olive-brown clay. There is no vertical offset of the adjacent lithologic units and differing lithologic units are not juxtaposed. There are no shears or slickensides in the clay. This feature appears to be a minor secondary fault trace.

Based on our studies, there is no major trace of the Seal Cove fault on the property. However, there is a minor trace that should require a 10-foot offset. The main trace is estimated to be as little as 10 feet west of the northwest corner of the property, as shown in Figure 6. The trace shown in Figure 6 is derived by connecting the mapped traces located in trenches to the north and south. The location is very approximate, since the trenches were somewhat far away. However, our fault trench on the property clearly showed that the main trace is not on the property.

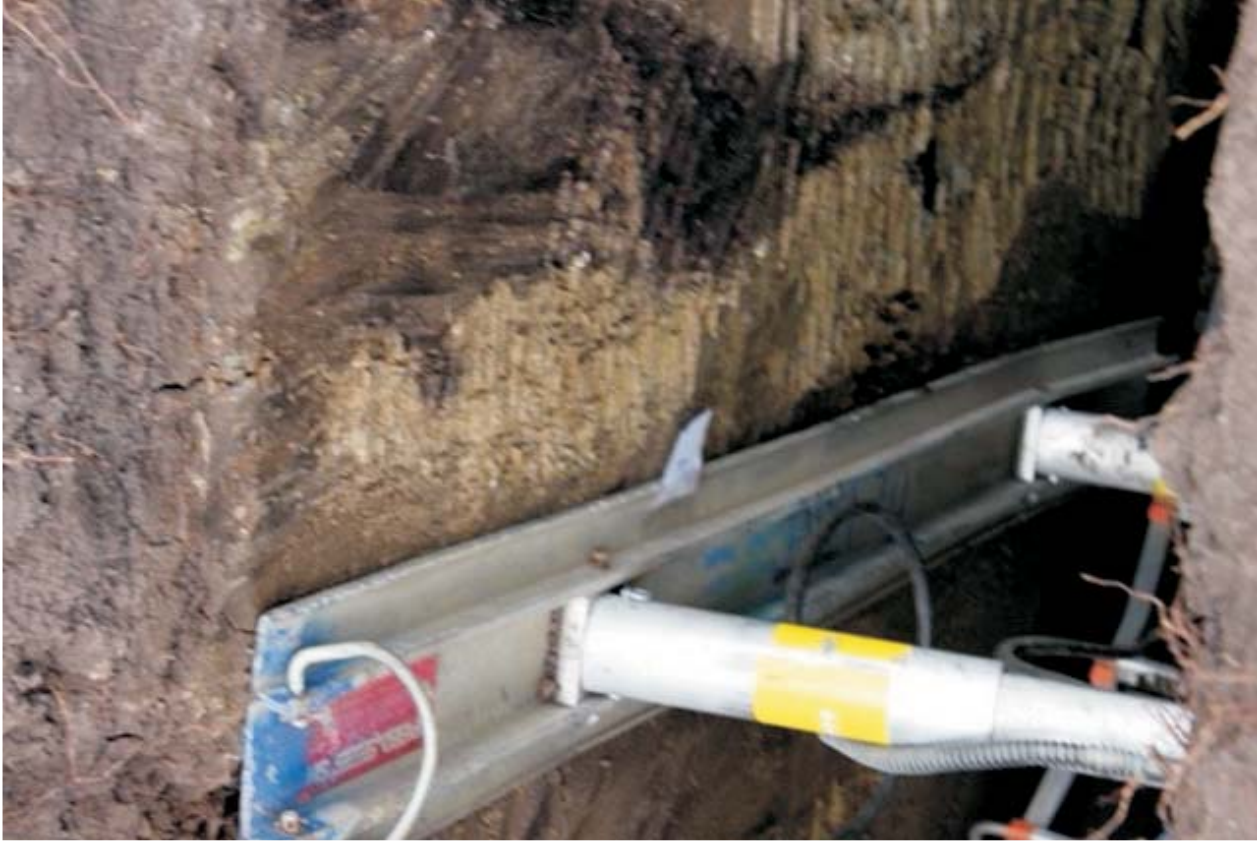
Fault trace at Shore #1

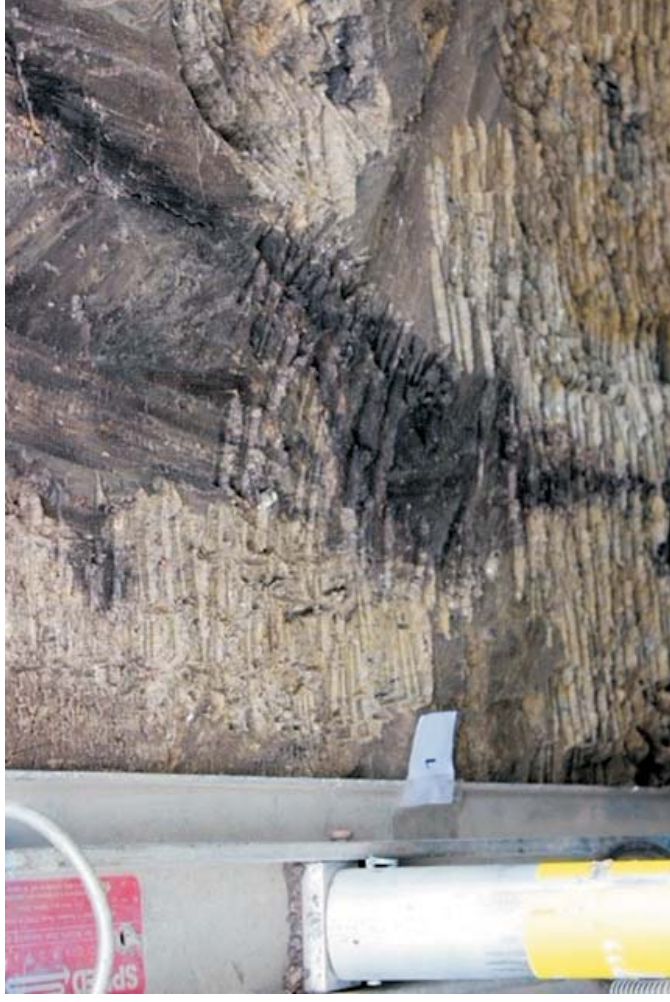
Fault trace at Shore #1

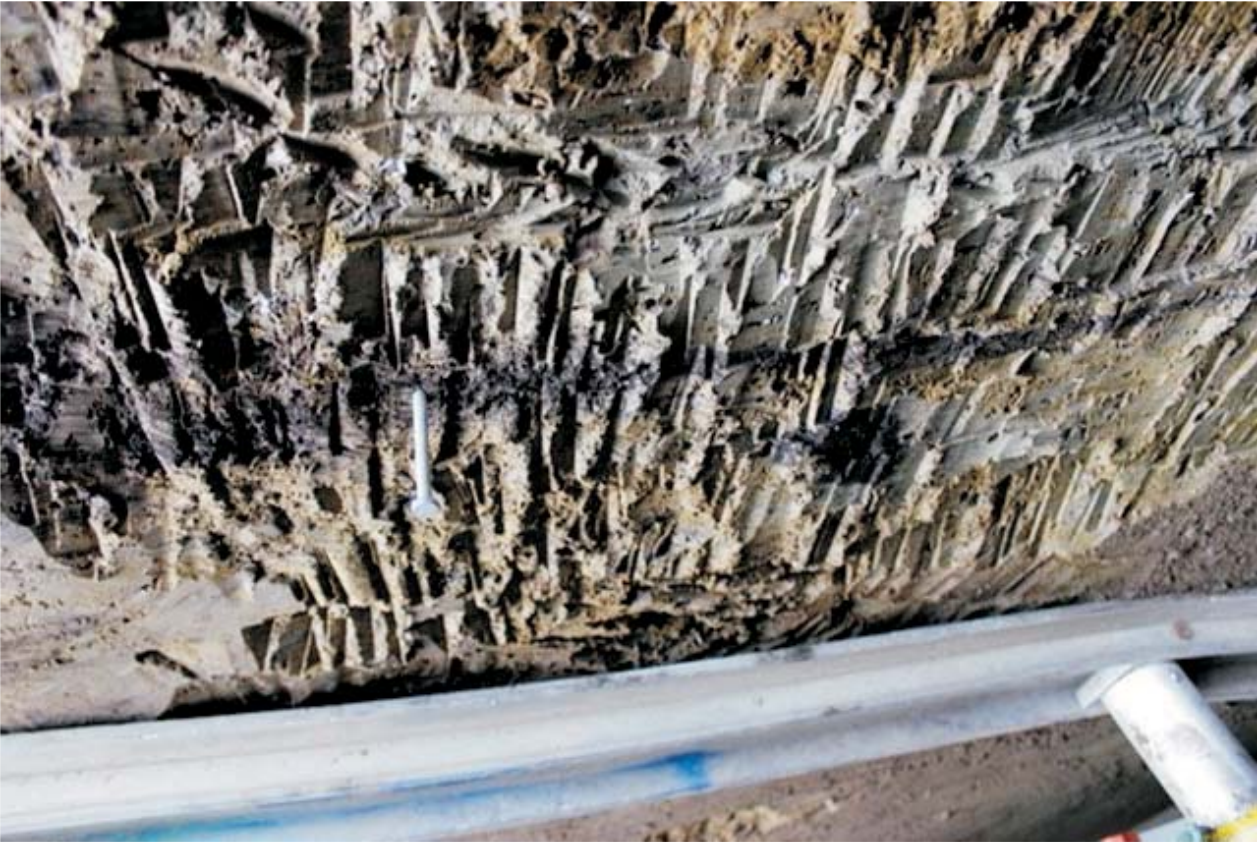
Fault trace at Shore #1

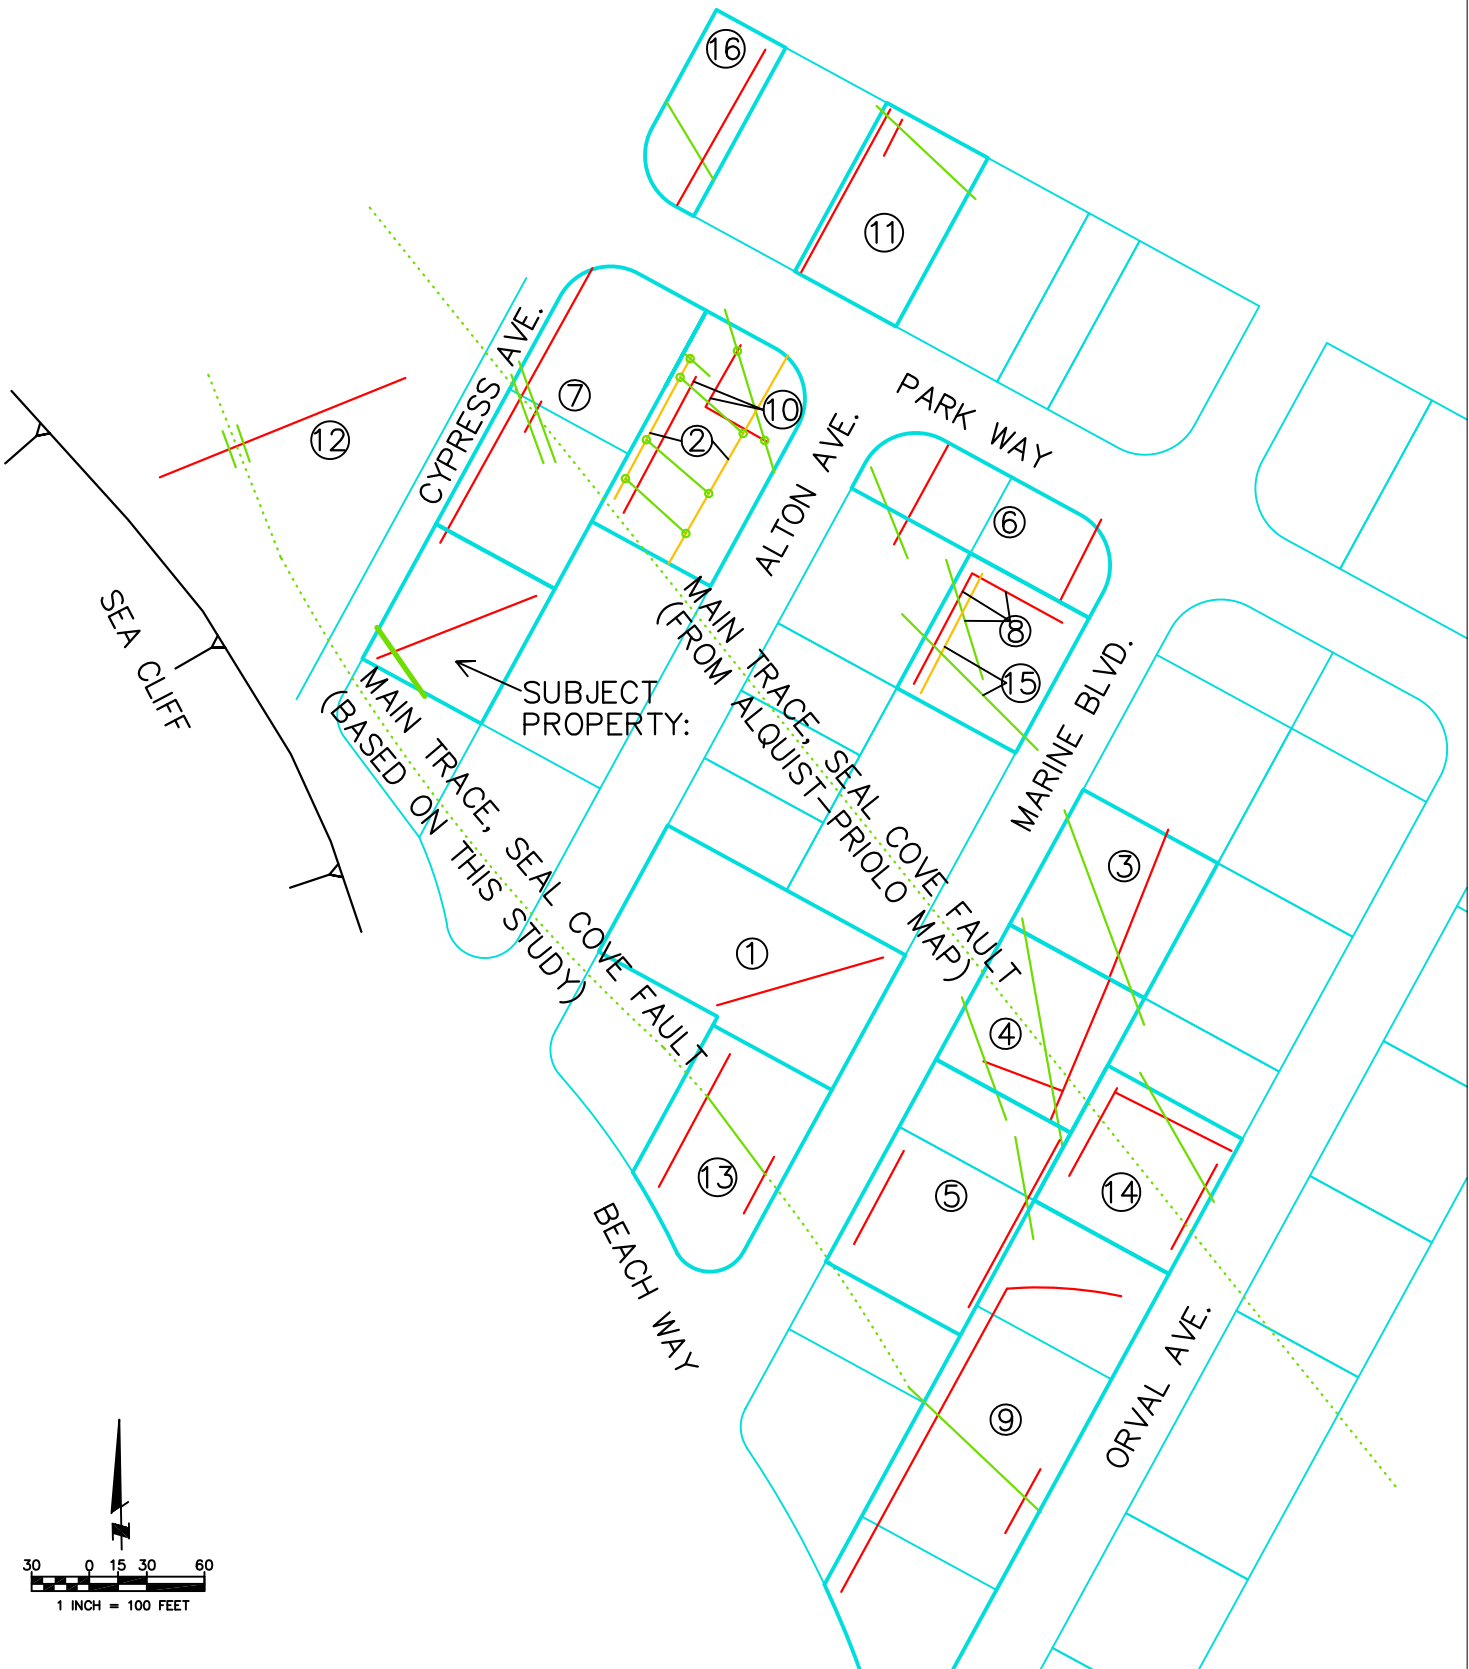
<p>Sigma Prime Geosciences, Inc.</p>	Figure 6
	Date: 12/19/17
	Job No.: 17-128
<p><b>Faulting in Study Area</b> Mukaeda Property, Cypress Ave., Moss Beach</p>

As Figure 6 shows, the most likely main trace of the fault borders the west side of the neighborhood, as identified in 3 of the studies (Numbers 9, 12, and 13). The other identified fault traces to the east are scattered and discontinuous, with no obvious major fault characteristics.

Figure 6 also shows the original location of the main fault trace, based on the Alquist-Priolo Special Studies Zone map, compiled by the State of California. This is the location that Simpson et al concluded was erroneous. Further evidence to

support the incorrect placement of the fault occurs in many of the reports we reviewed. As Figure 6 shows, several of the trenches by other consultants should have crossed the main trace of the fault. Most notably, the property along Cypress Avenue (Reference #7) should have revealed a major seismic feature. Instead, the trench log describes minor, 2 to 4 inch wide fractures with no changes in lithology.

Based on our desk study, it appears very likely that the Seal Cove fault follows the westward trend shown in Figure 6. The features mapped to the east are ground fractures and other minor ground disruptions likely associated with past seismic events. Some of these features may be the result of no more than a few inches of displacement at a time when the causative seismic event resulted in several feet of displacement along the main fault trace. Future events may produce similar ground disruptions in the neighborhood, either at the same locations, or at other, new locations.
