County of San Mateo - Planning and Building Department

ATTACHMENT K

**ENGINEERING GEOLOGIC &
GEOTECHNICAL INVESTIGATION
4 LOT RESIDENTIAL DEVELOPMENT
ZMAY PROPERTY
1551 CRYSTAL SPRINGS ROAD
SAN MATEO COUNTY, CALIFORNIA**

RE: ENGINEERING GEOLOGIC &
GEOTECHNICAL INVESTIGATION,
4-LOT RESIDENTIAL DEVELOPMENT,
ZMAY PROPERTY,
1551 CRYSTAL SPRINGS ROAD,
SAN MATEO COUNTY, CALIFORNIA

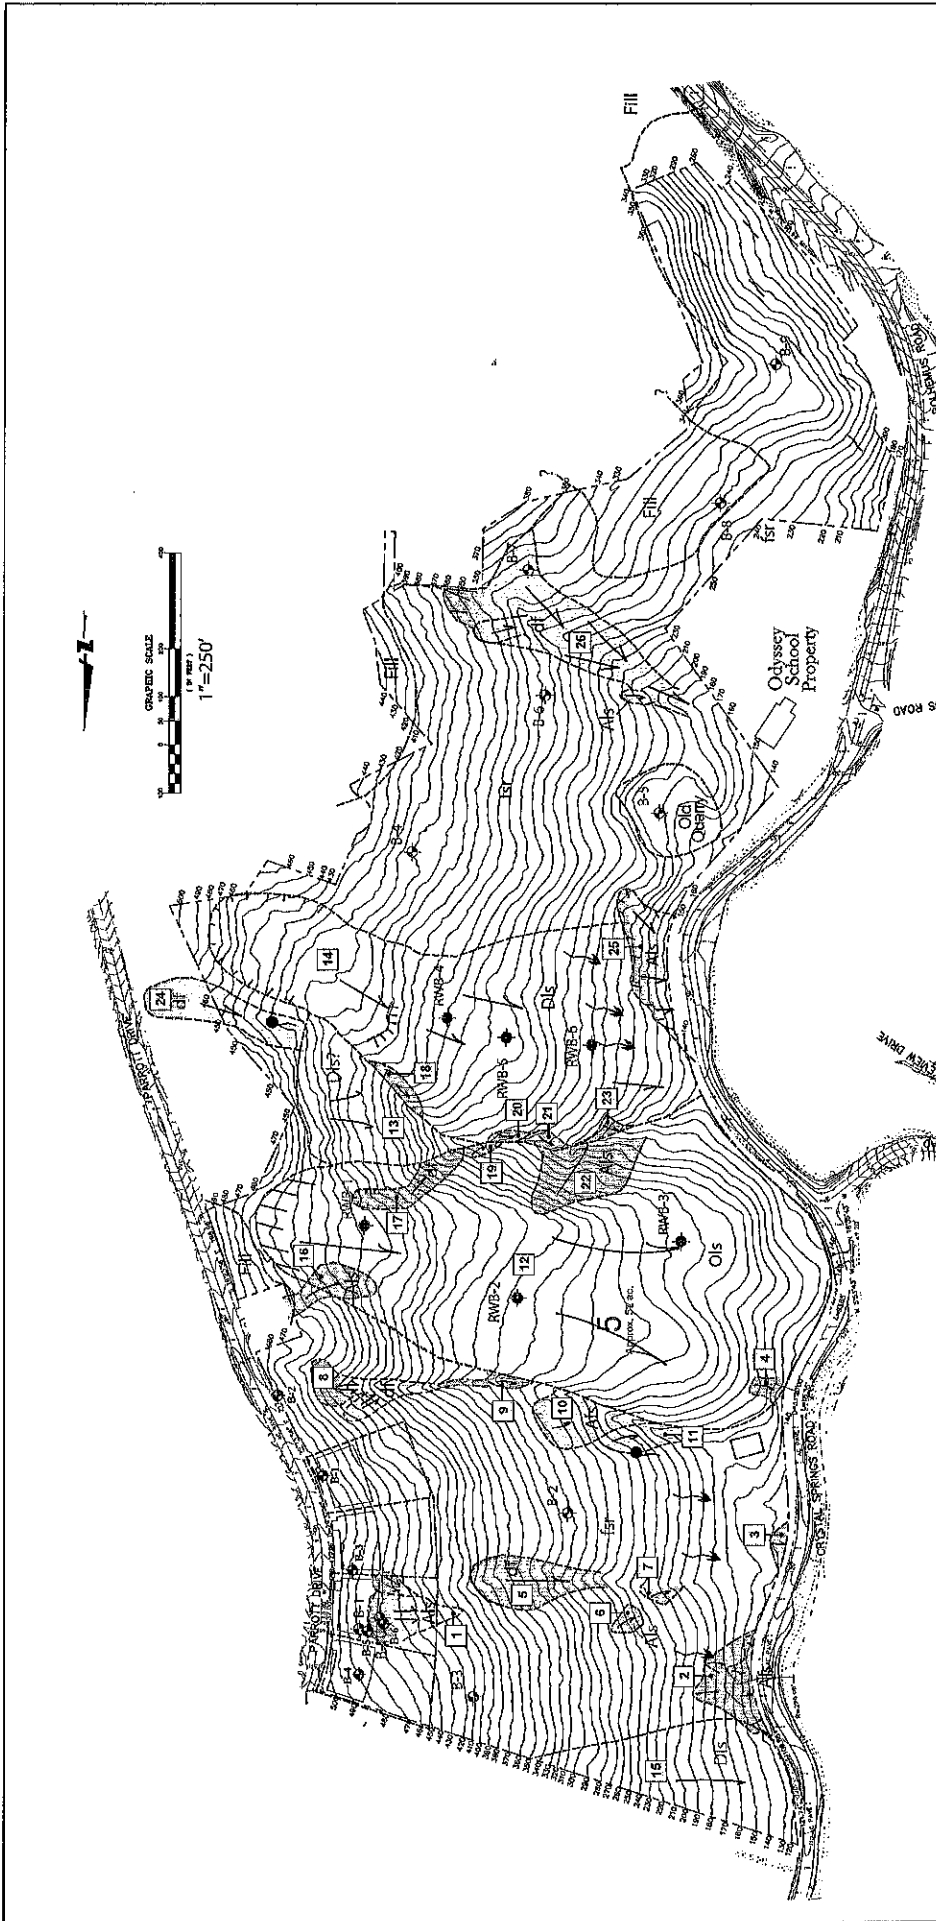
SITE PLAN & ENGINEERING
GEOLOGIC MAP

An active relatively shallow landslide (1) is located near the northeastern property corner within the proposed Lot 2 of the referenced 4-lot subdivision. Based on our review of aerial photographs, our site reconnaissance, and as previously discussed in our referenced subdivision report, it appears that a 40-foot wide failure appears to have occurred along the downhill side of the graded access road, widening the area of the active landslide from what was previously mapped. This active landslide was absent from the 1943 and 1968 aerial photographs, but appeared in the latest photographs following construction of the graded access road (as discussed above). In our opinion, grading associated with construction of this road is likely the main probable cause of the landslide. It appears that this active landslide is less than 10 feet thick in depth.

An additional active, relatively shallow landslide (2) is located near the northwest property corner, along the road cut above Crystal Springs Road. Based on our site reconnaissance, this feature appears to be approximately 200 feet wide and approximately 100 feet in length. The slide mass is characterized by generally hummocky topography. In our opinion, grading associated with construction of Crystal Springs Road is likely the main probable cause for activation of the landslide. It appears that this active landslide is relatively shallow, likely less than 10 feet thick in depth. Two similar, smaller features (3 and 4) are located further south along Crystal Springs Road with slide mass dimensions of approximately 75 feet wide and approximately 25 feet in length and approximately 50 feet wide and approximately 60 feet in length, respectively.

- A) The approximate area for stabilization repair of active landsliding within Parcels 1 and 2 should be depicted in plan view and cross section. Conceptual design measures should be presented that are intended to prevent future reactivation or enlargement of landsliding across the common property line. If a grading repair is selected, approximate grading volume estimates should be prepared.*

Based on the reconfiguration of parcel boundaries, the majority of the mapped active landslide is located within Parcel 2. Please refer to Figure 1 for the reconfiguration of the proposed parcel lines and refer to Cross Section B-B' (Figure A-7) of MEI's 2014 report for reference. We understand that the project civil engineer will be providing a cross section depicting the proposed landslide repair, including keying and benching details of the fill, fill subdrainage, and grading volumes.

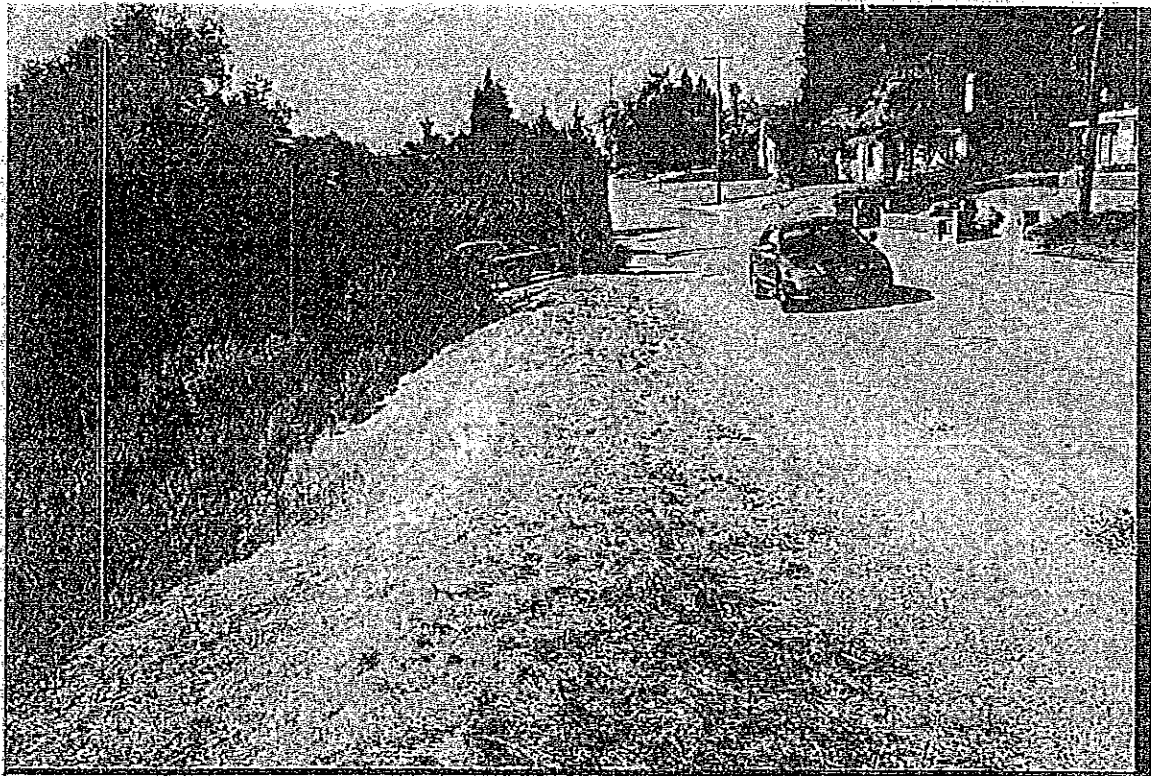
Main Lift Station Site approximately 30 feet left of MH 20 (in street)

The connection point and depth of the lateral, which serves the house adjacent to the pump station site at 1136 Parrott Drive, is unknown. The design should consider a wet well depth which would serve this property without the use of an additional individual pump station. (That design must also be sure that backflow devices are included on that line.) The current cost estimates include an individual pump station at that site.
